ST. MARY'S RIVER WATERSHED  
SITE NO. 1

PHASE I INSPECTION REPORT  
NATIONAL DAM INSPECTION PROGRAM

ST. MARY'S RIVER WATERSHED, SITE 1,

PHASE I INSPECTION REPORT

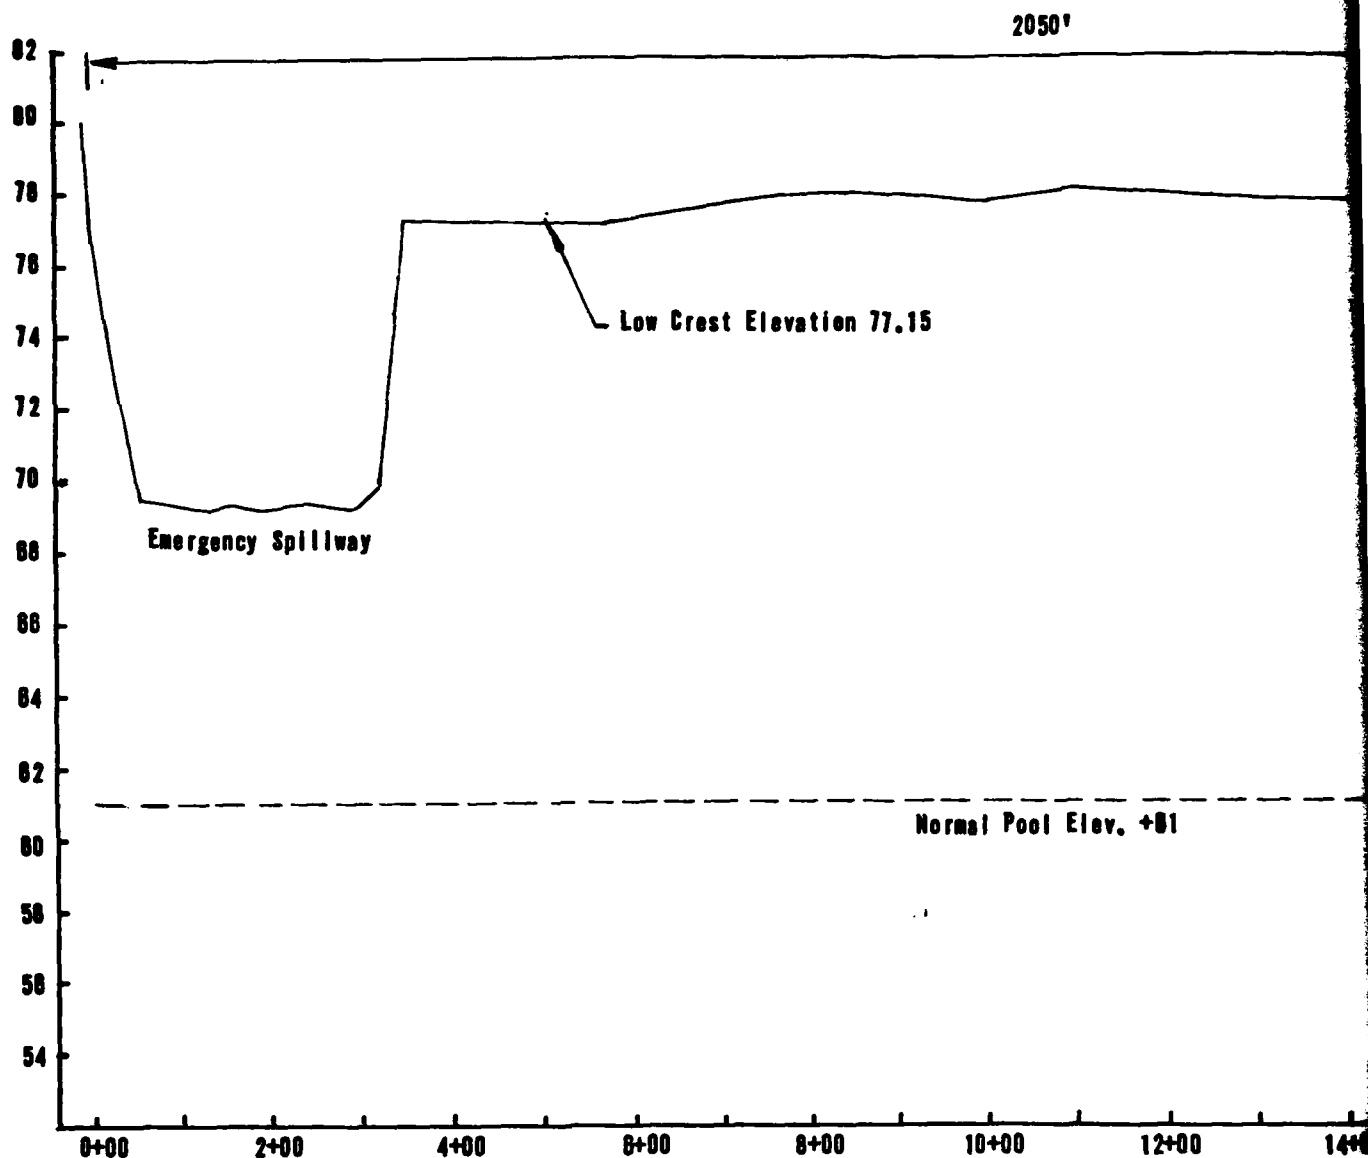
**DAM CREST SURVEY**  
**(LOOKING UPSTREAM)**

The crest of the dam was surveyed and the variance in elevation was 10.5 inches between the high and low point. Also, the low point on the crest is 0.6 inches above the design dam crest elevation of 77.1 feet above m.s.l. It should be noted that the crest elevations were referenced to a pin set by the U.S. Soil Conservation Service in a tree along the right abutment of the dam. Freeboard at the time of inspection was approximately 16 feet, and under design maximum pool conditions would be approximately 5.9 feet. The dam crest profile is included on Plate A-2.
